## Tree Roots vs House Foundation Bélisle Project - Montréal, Québec

### Installation

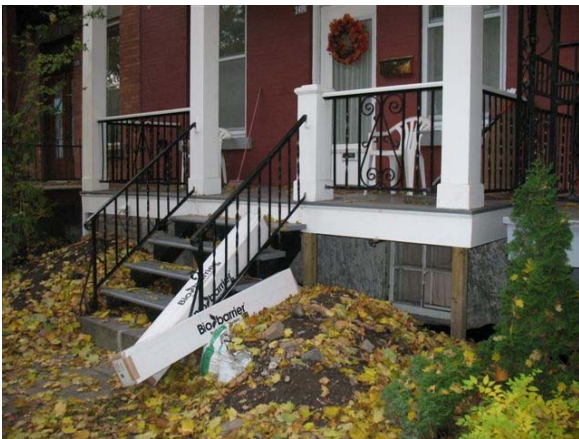
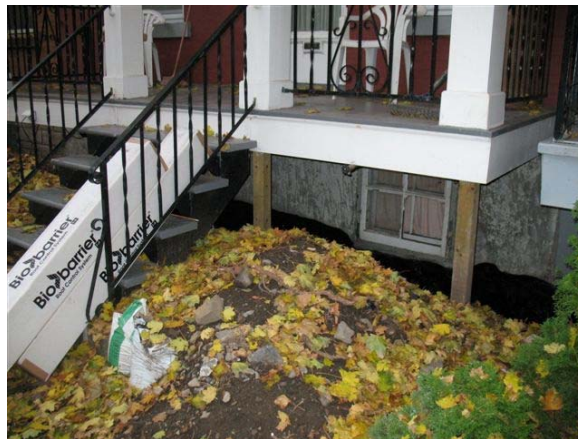
A trench was dug in the front of the centennial house.

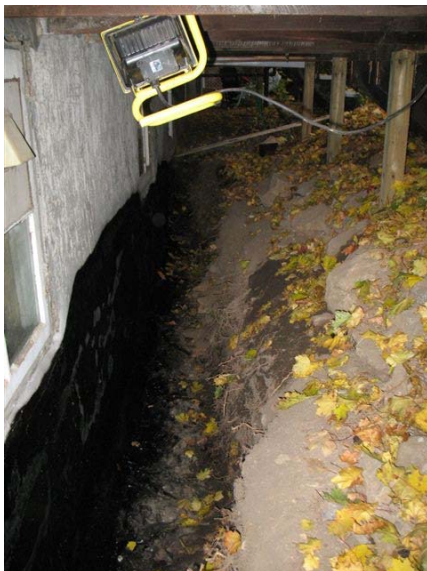
The foundation and footing were exposed.

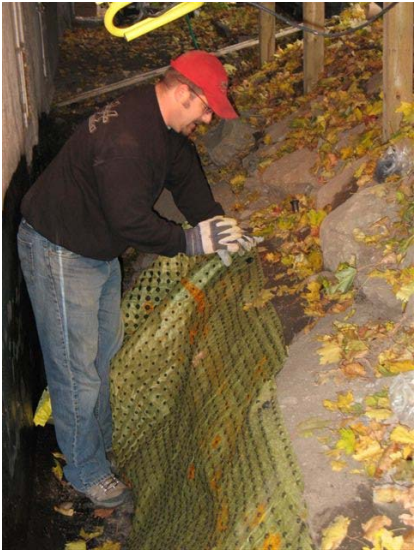
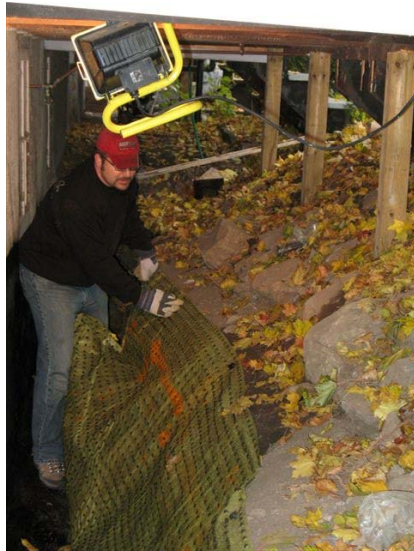
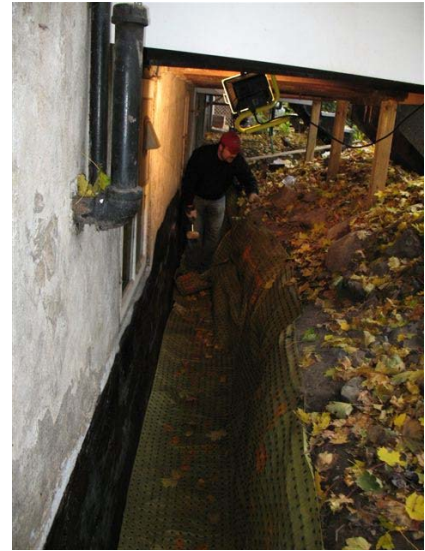
Biobarrier was positioned on the vertical slope and secured in place using plastic pegs.

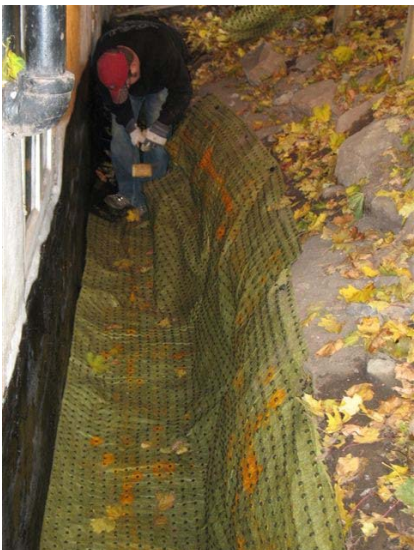
Biobarrier was also applied over the horizontal section of the footing.

For waterproofing, the foundation wall was treated with an elastomeric asphalt, extruded insulation panels were then placed over the foundation wall before filling the trench with soil.
